Central-West Orana Renewable Energy Zone Transmission project

Amendment Report

Appendix H: Aboriginal Cultural Heritage Assessment Report Addendum

March 2024

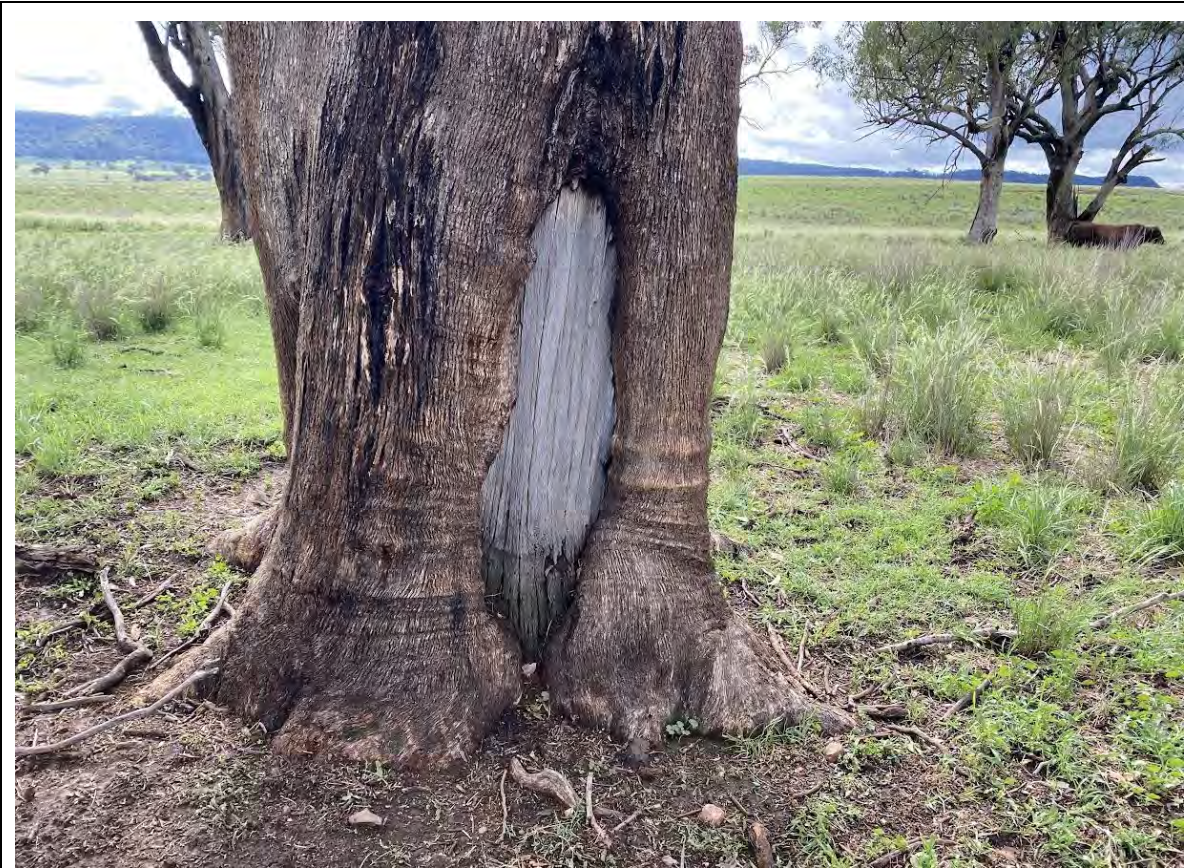
Image 1: While Tree SNI-CMT11 may be old enough to be a scar tree, the scar is far too recent.

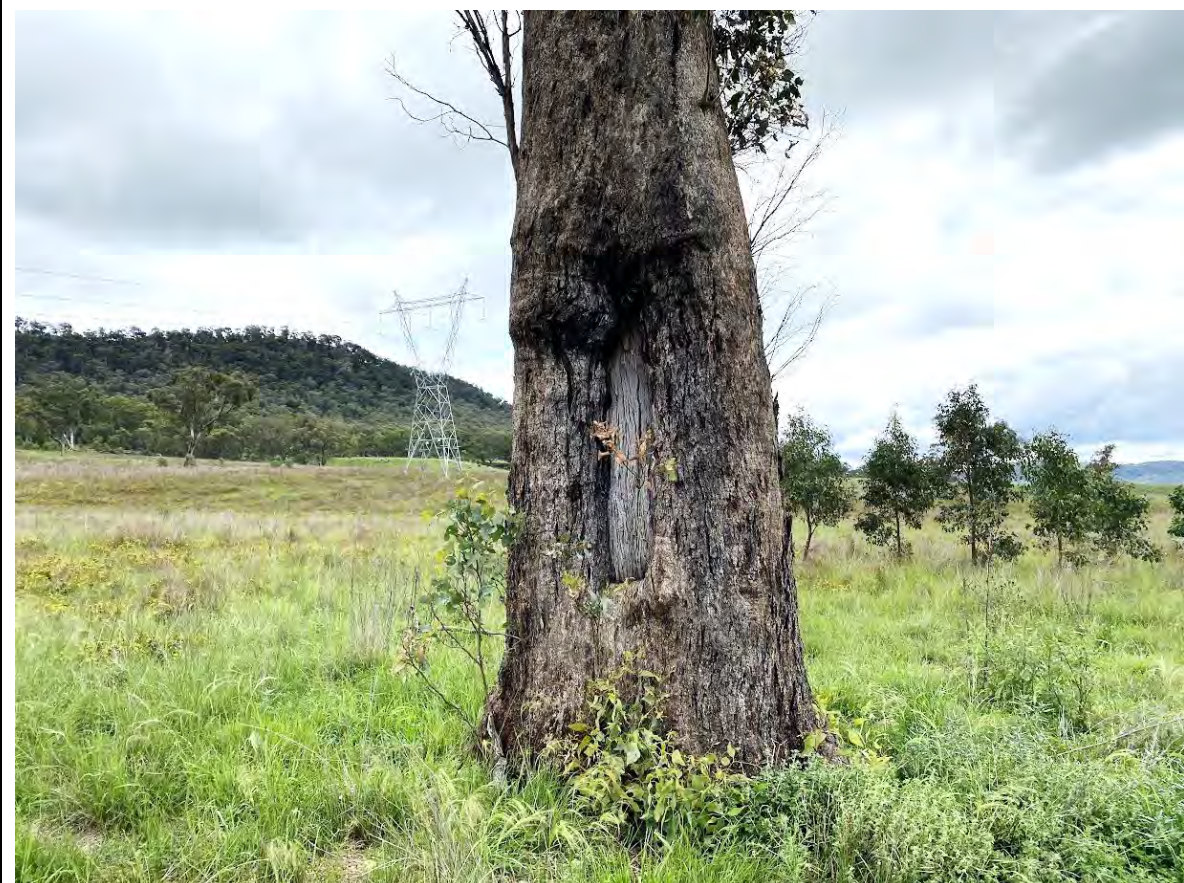
Image 2: Tree SNI-CMT03 is old enough to be a scar tree, but the wound is still relatively recent and unacceptably large.

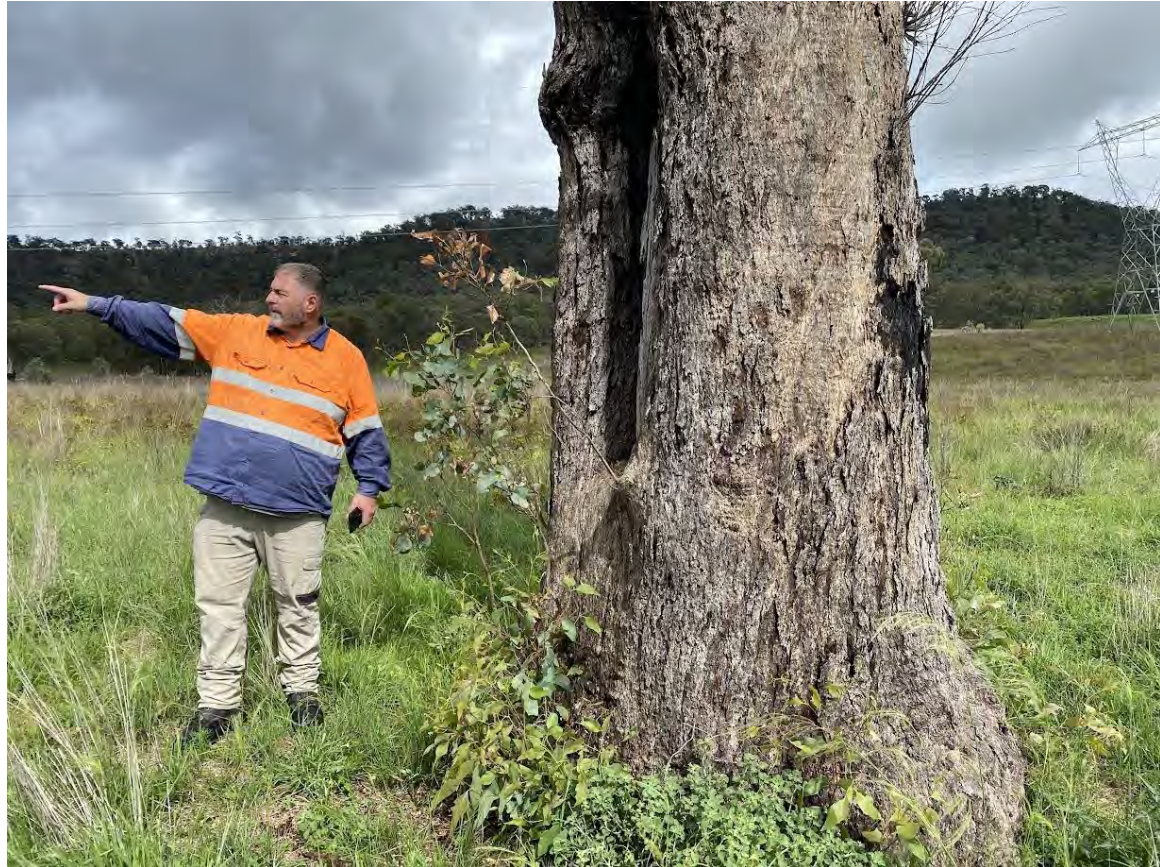
Image 3: The height and location of the scar on Tree SNI-CMT03 are inconsistent with cultural scarring. The location means that it is not a canoe tree.

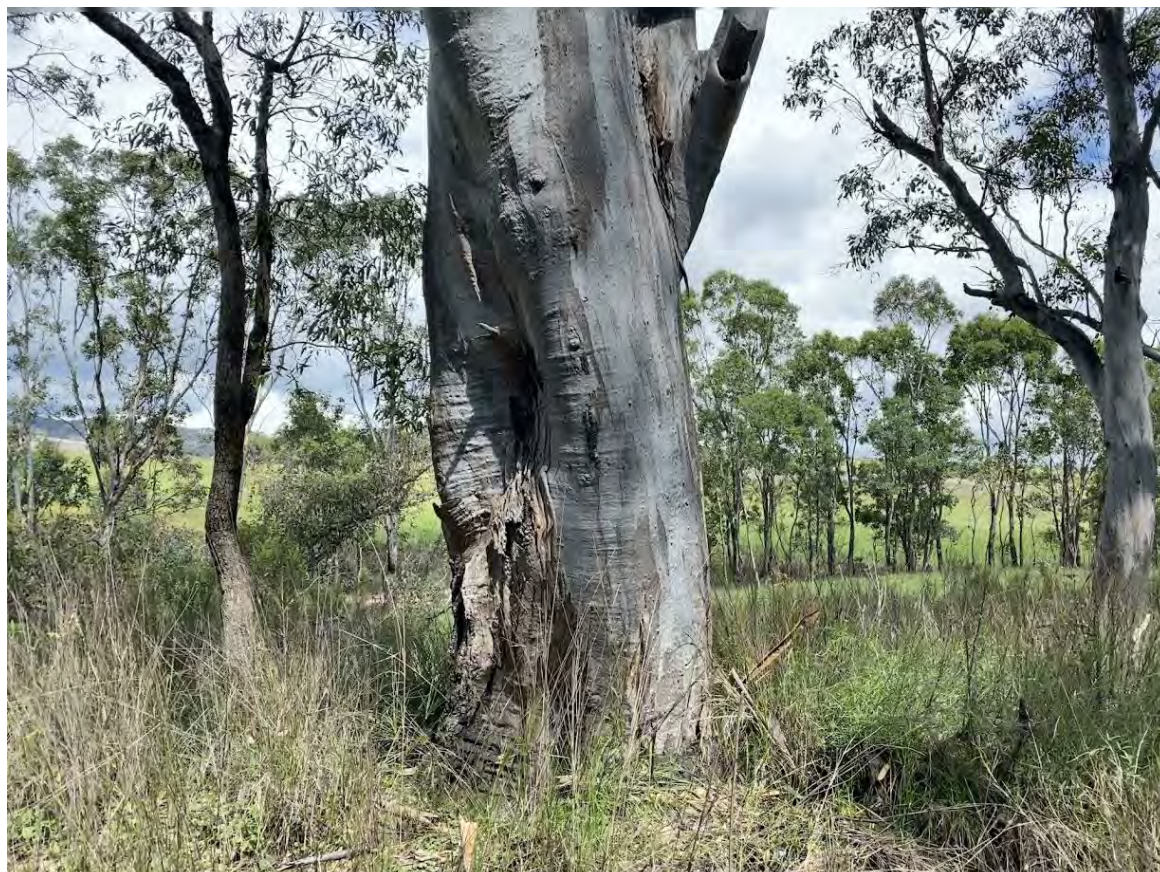
Image 4: Tree 36-3-0565 is only just old enough to be a scar tree, but the wound appears to be associated with an old stem failure.

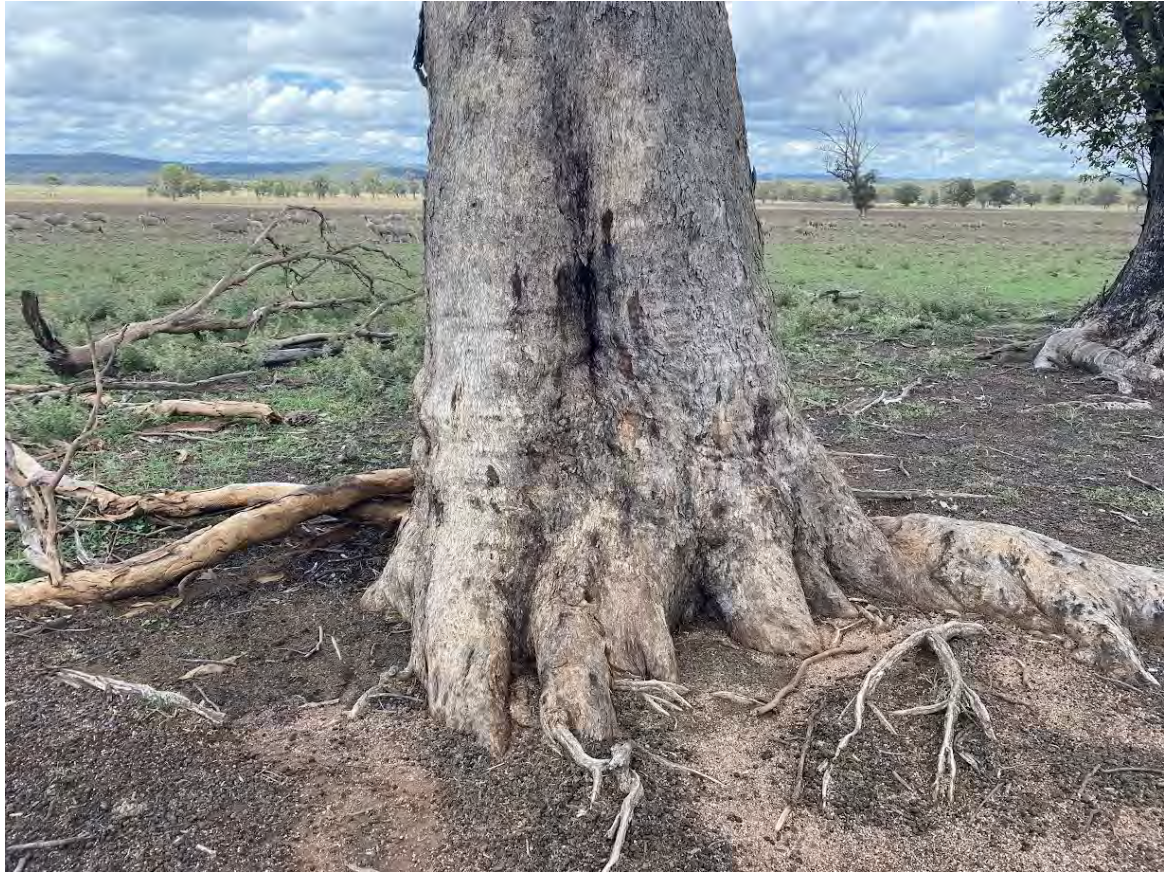
Image 5: Based on the initial dimensions, Tree SNI-CMT01 may be old enough, and the wound was deep enough to merit consideration.

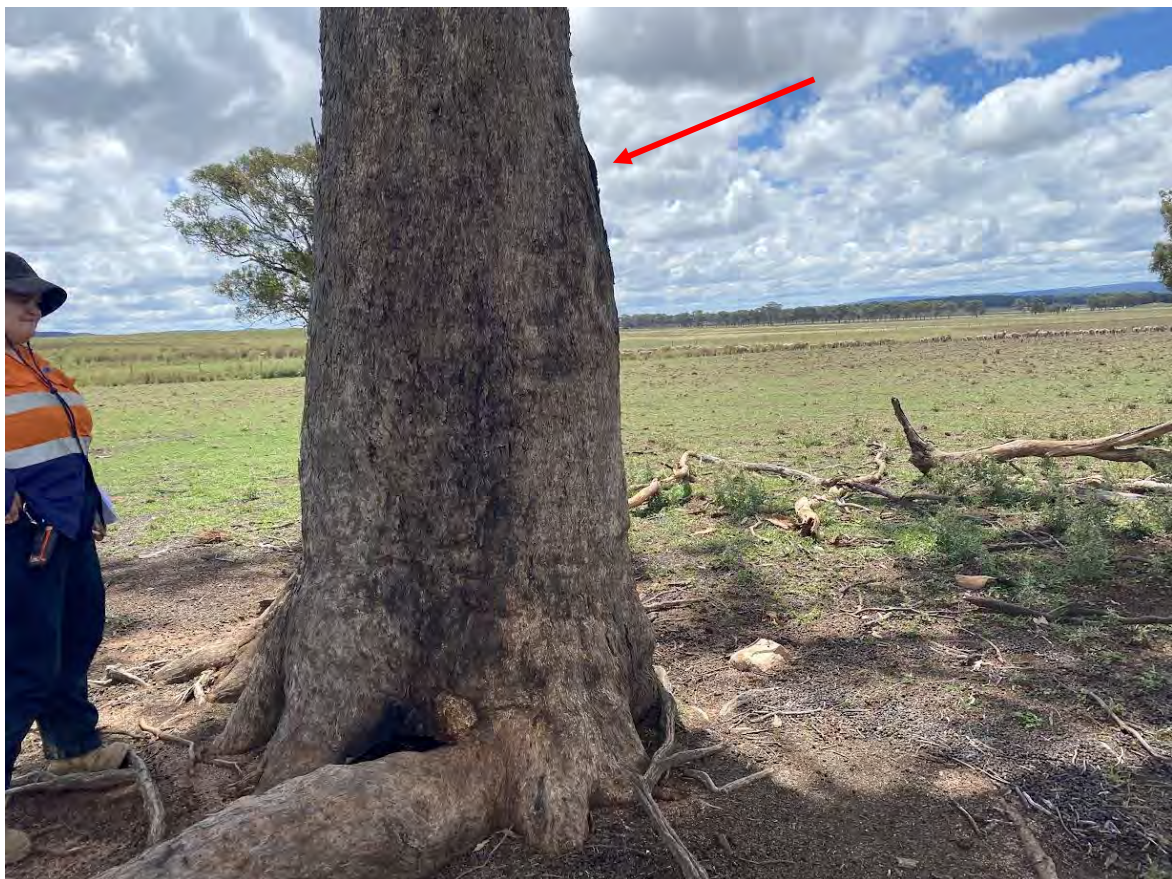
Image 6: There is swelling at the base of the tree, suggesting the presence of an internal cavity, which could be consistent with a coolamon.

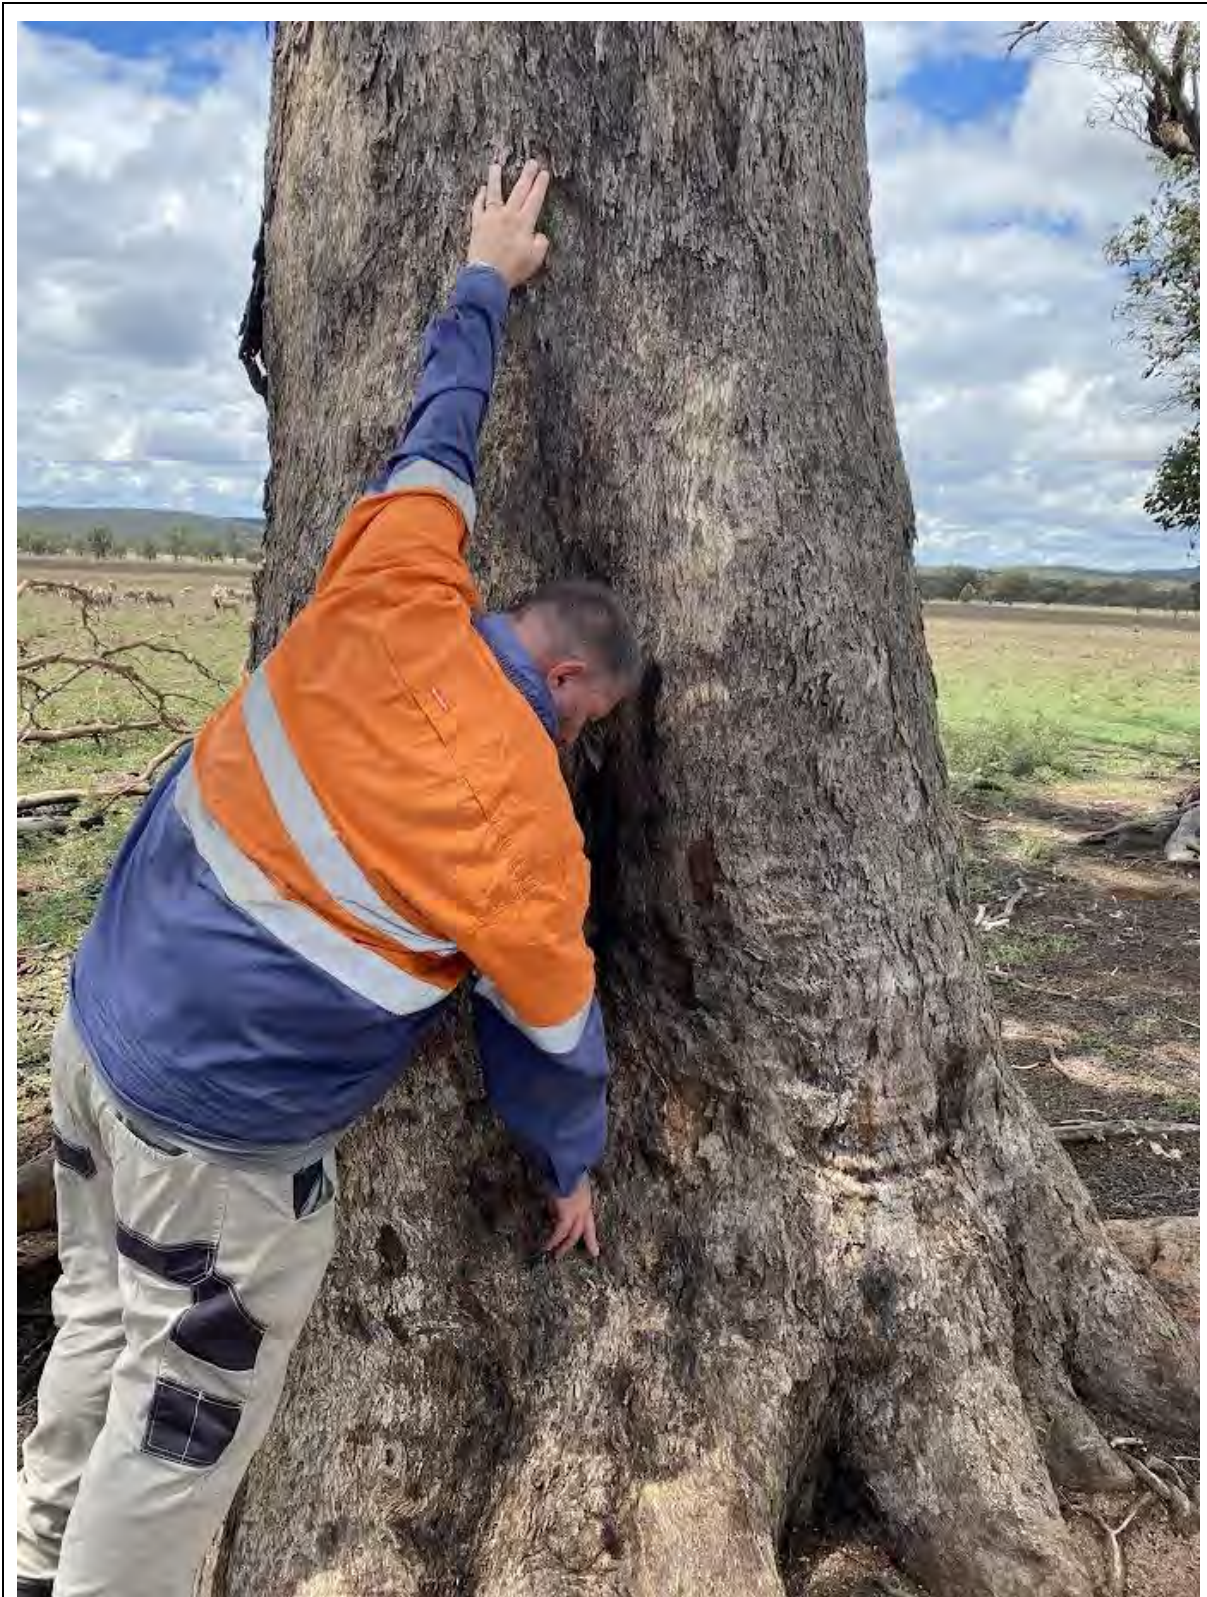
Image 7: The length of the scar eliminates the possibility of the tree being used for anything other than bark for shelter, and this seems highly improbable for other reasons.

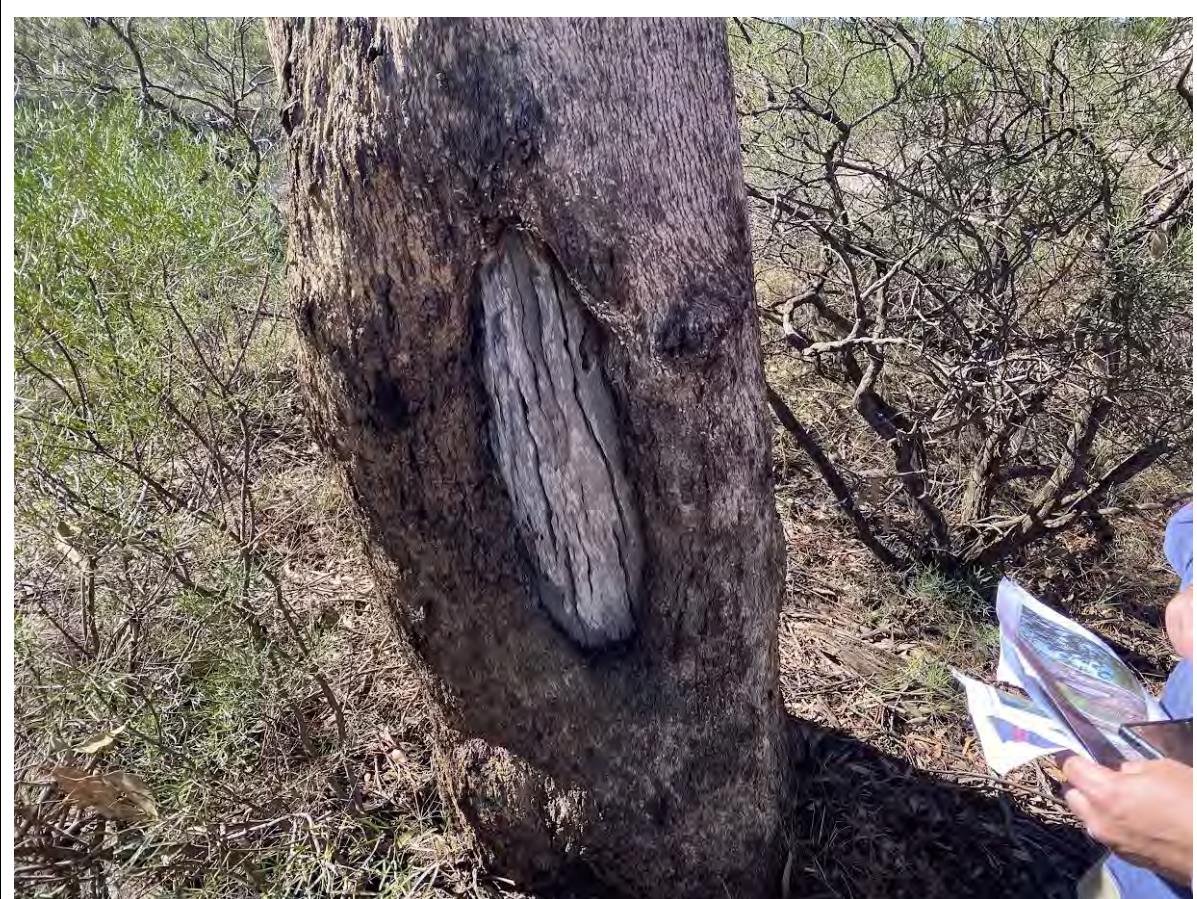
Image 8: While the wound is an ideal size and shape, Tree SNI-CMT20 is too young to be a scar tree. It is likely that this scar was formed as a result of impact by a grader.
