# Central-West Orana Renewable Energy Zone Transmission project

### Appendix H: Aboriginal Cultural Heritage Assessment Report Addendum

## **Aboriginal cultural heritage assessment addendum**

E230829 RP1

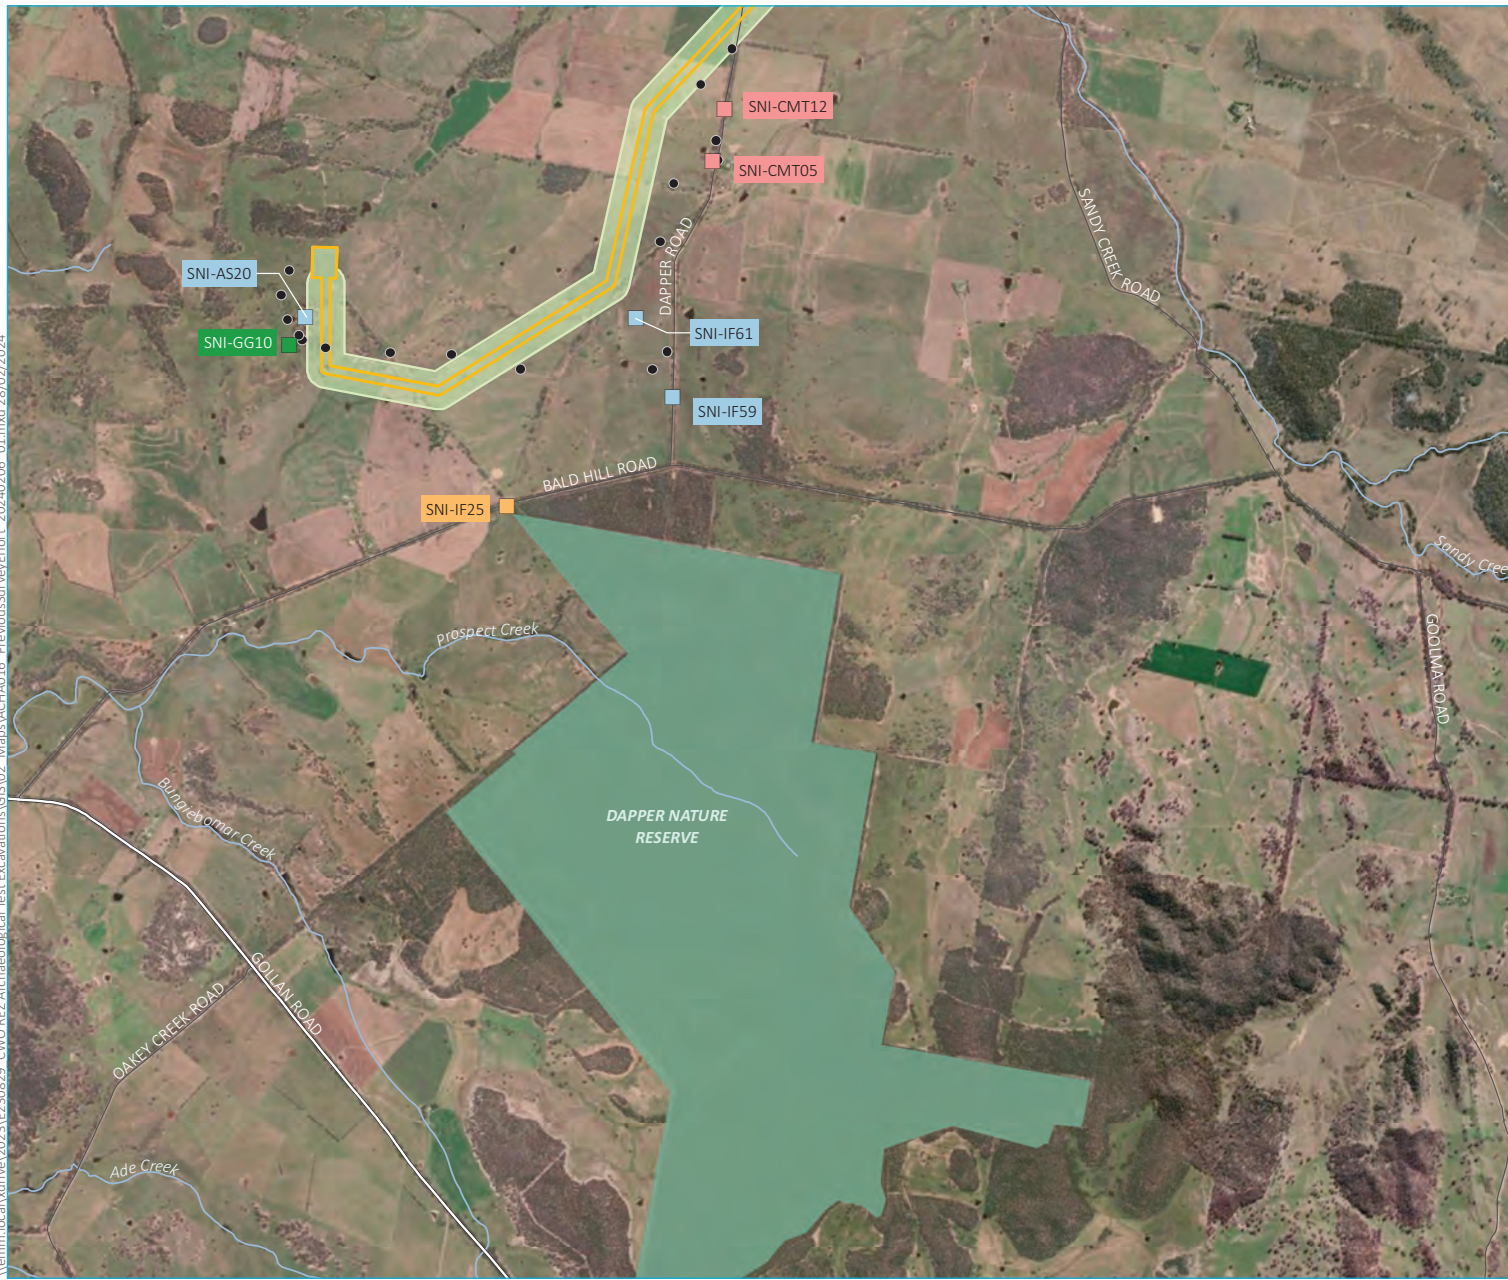
Summary of previous survey effort and findings  
Map 1 of 18

- KEY**
- Exhibited construction area
  - Observation point
  - Identified Aboriginal site
  - Artefact scatter
  - Culturally modified tree
  - Grinding groove
  - Isolated artefact
  - Survey status
  - Survey complete
  - Existing environment
  - Major road
  - Minor road
  - Named watercourse
  - NPWS reserve
- INSET KEY**
- Major road
  - NPWS reserve
  - State forest

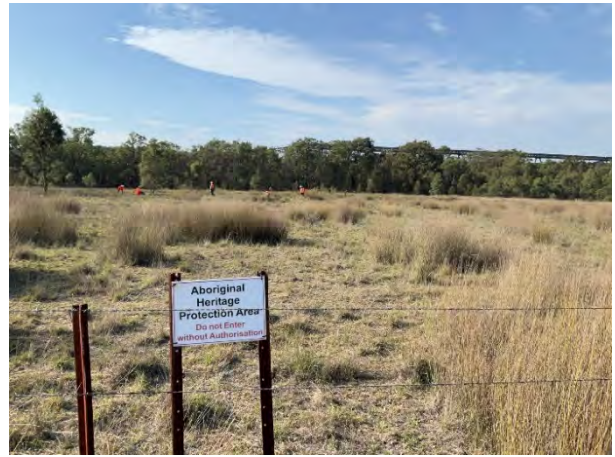
**Plate 4.1** Undulating grassy flats typical of SU 1, facing north

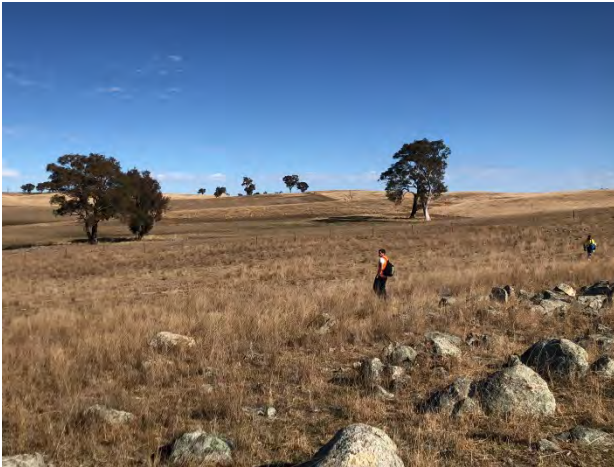
**Plate 4.2** Flat valley terrain found in SU 2 with Wilpinjong coal mine infrastructure visible in the background, facing south-east

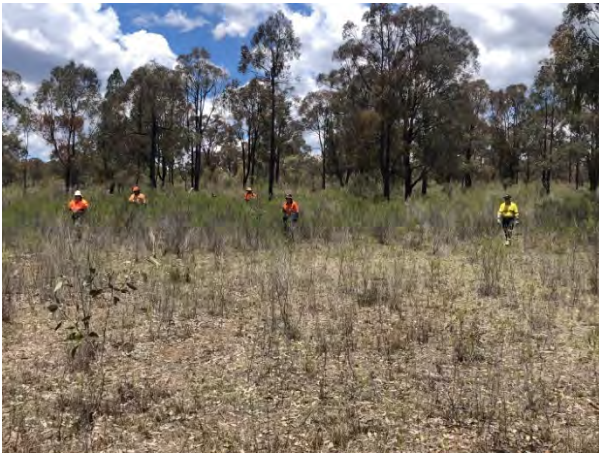
**Plate 4.6** Example of isolated trees on low-lying hills typical of the previously cleared land in SU 6, facing west

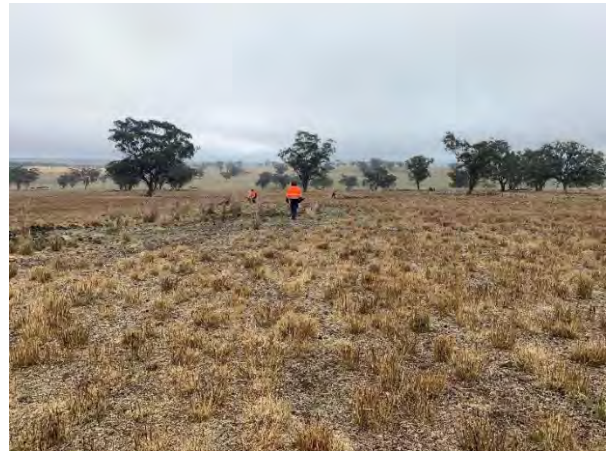
**Plate 4.7** Outskirts of remnant woodland commonly found in areas bordering pastoral fields in SU 7, facing east

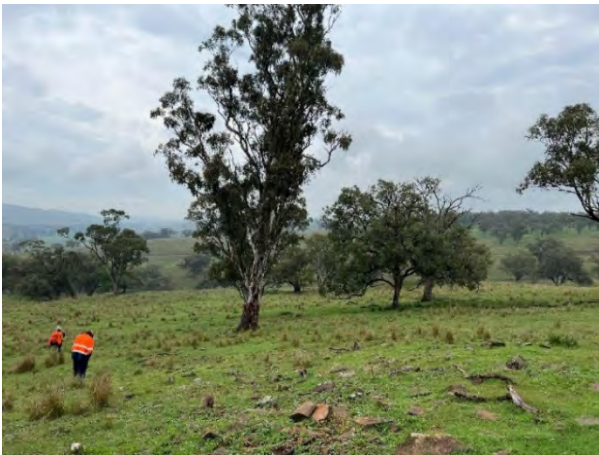
**Plate 4.8** View from the top of undulating hills typically found in SU 8, facing north
